Roanoke, Town of  
(Roanoke Methodist Protestant Church, Parsonage)  
Roanoke  
Lewis County  
West Virginia

HABS No. WV-209-B

WRITTEN HISTORICAL AND DESCRIPTIVE DATA

ROANOKE, TOWN OF HABS No. WV-209-B  
(Roanoke Methodist Protestant Church, Parsonage)

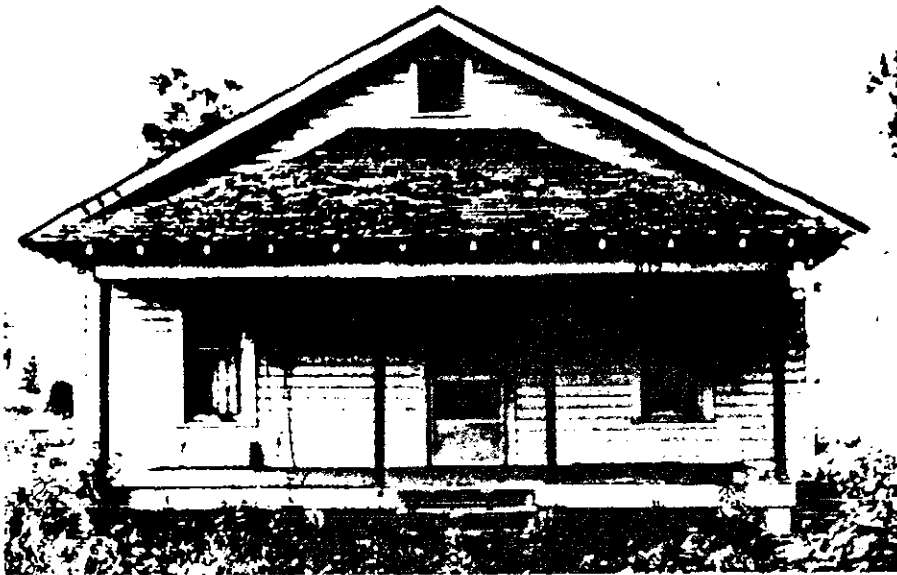
Perspective control photograph of the southeast elevation of the Roanoke Methodist Protestant Church parsonage in 1981. Note church at right.

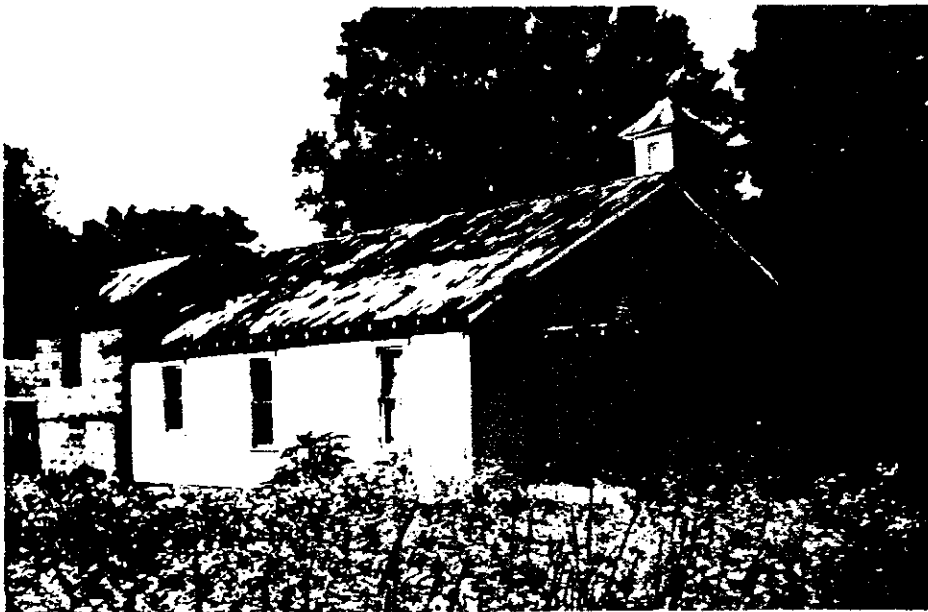
Perspective control photograph of the southeast and southwest elevations of the Roanoke Methodist Protestant Church parsonage in 1981. Note cellar house at left.

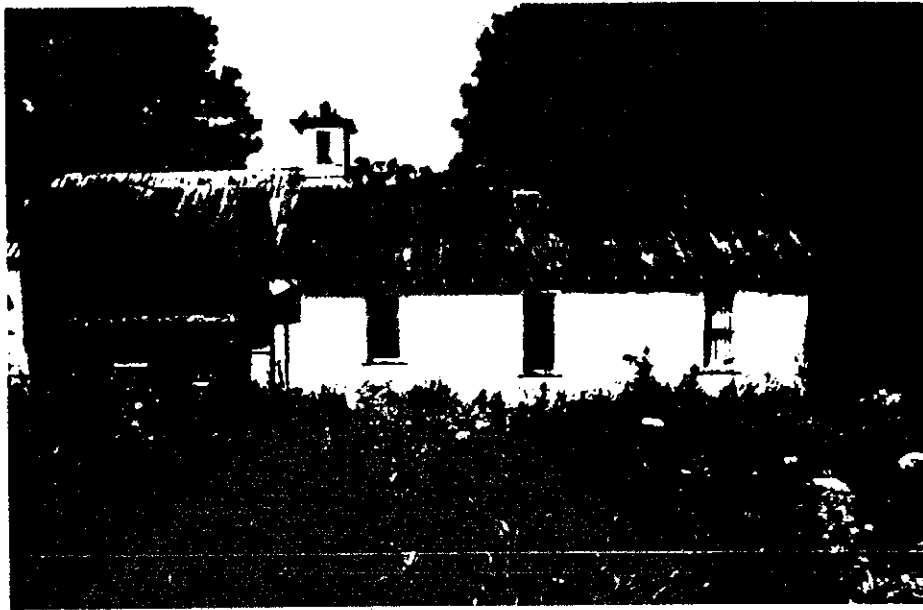
Perspective control photograph of the southwest elevation of the Roanoke Methodist Protestant Church parsonage in 1981. Note cellar house at left and church in the background.

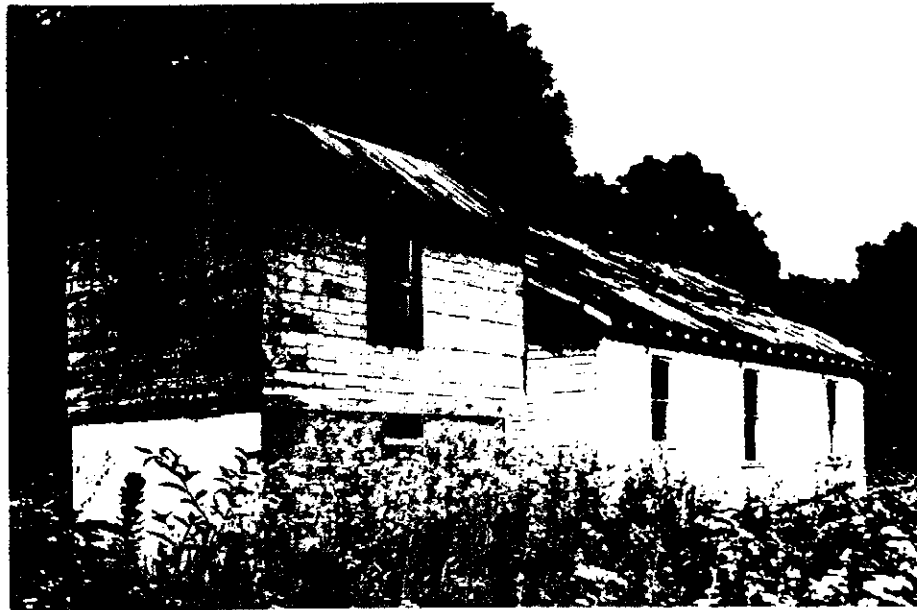
Perspective control photograph of the southwest and a portion of the northwest elevations of the Roanoke Methodist Protestant Church parsonage in 1981. At left is the cellar house on the same tract.

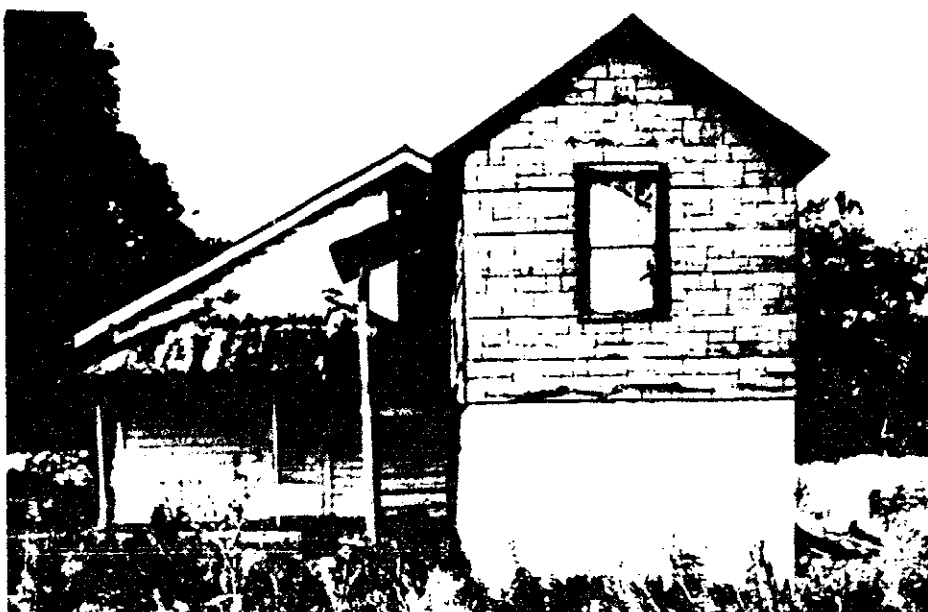
Perspective control photograph of the northwest elevation of the Roanoke Methodist Protestant Church parsonage in 1981. Note the exterior steps to the second floor of the cellar house.

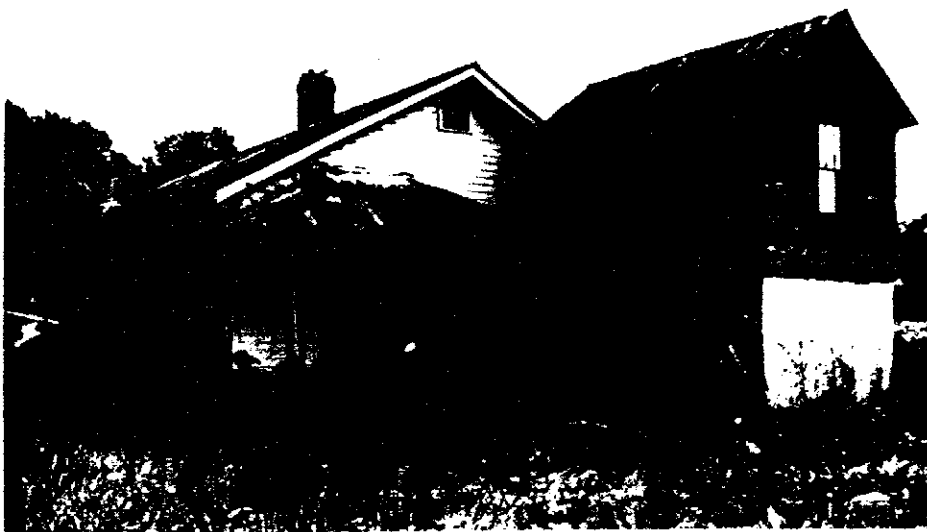
Perspective control photograph of the northwest and northeast elevations of the Roanoke Methodist Protestant Church parsonage in 1981. Note cellar house at right.

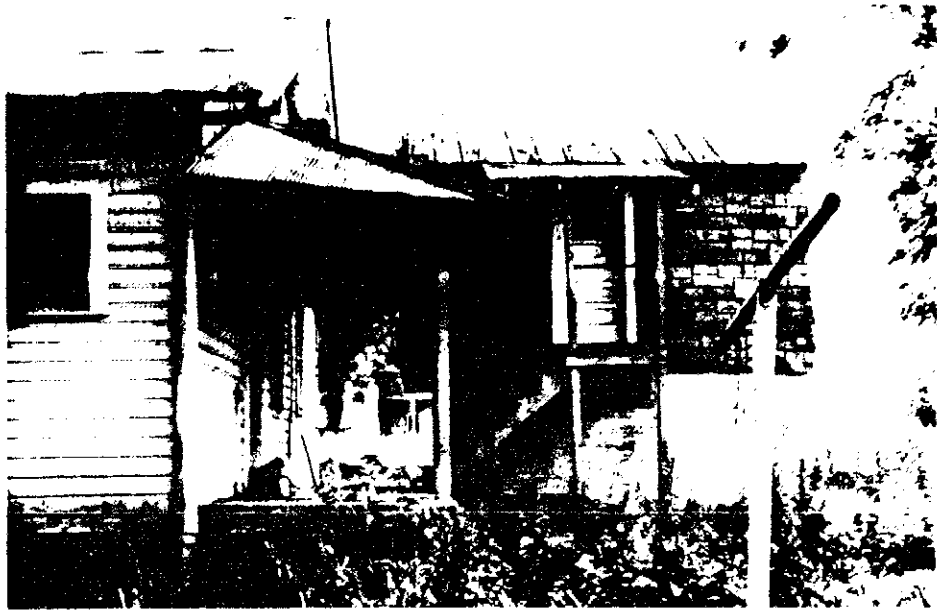
A rear porch centered opposite the offset doorway in the northwest elevation measures 6' wide x 15'6" long, and the deck is raised 2'4" above the ground.

The deck rests on three evenly-spaced piers built of three 8" concrete blocks stacked horizontally and is composed of 5 1/4"-5 3/4" boards which are painted medium gray. The hipped roof is covered with corrugated sheet metal; it is supported on the northeast end and in the middle by two 2" x 4" columns. On the southwest end, the roof is nailed into the wall of the cellar house. Steps at both the northeast

Porch attached to the northwest elevation of the Roanoke Methodist Protestant Church and the cellar house as they appeared in 1981.

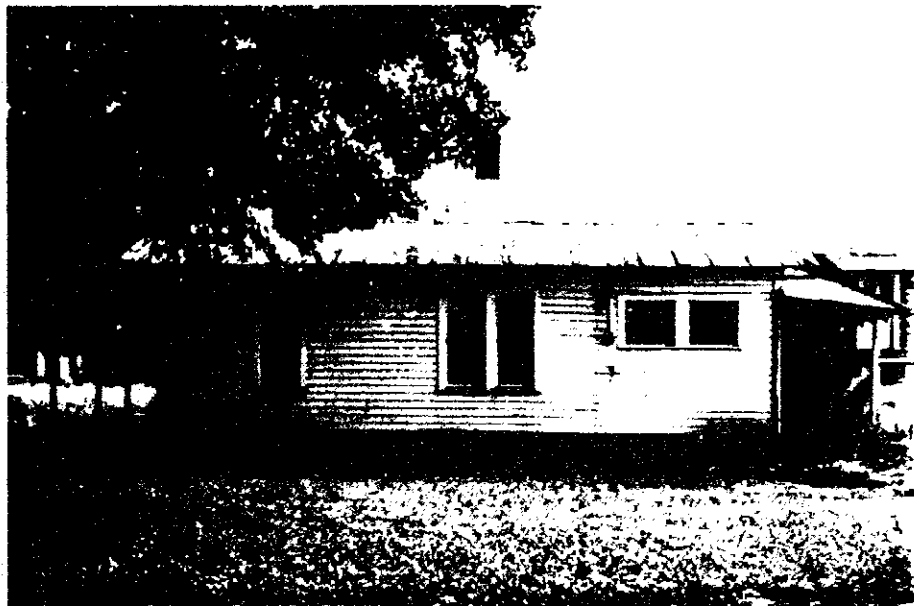
Perspective control photograph of the northeast elevation of the Roanoke Methodist Protestant Church parsonage in 1981.

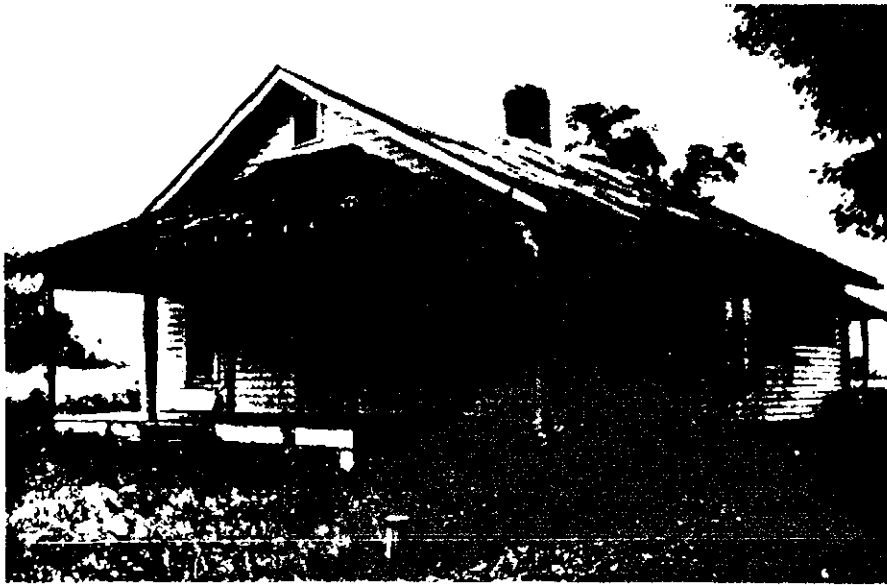
Perspective control photograph of the northeast and southeast elevations of the Roanoke Methodist Protestant Church parsonage in 1981. The porch attached to the southeast elevation is clearly visible, and it fronts on the old Weston and Gauley Bridge Turnpike (County Route 23/5).

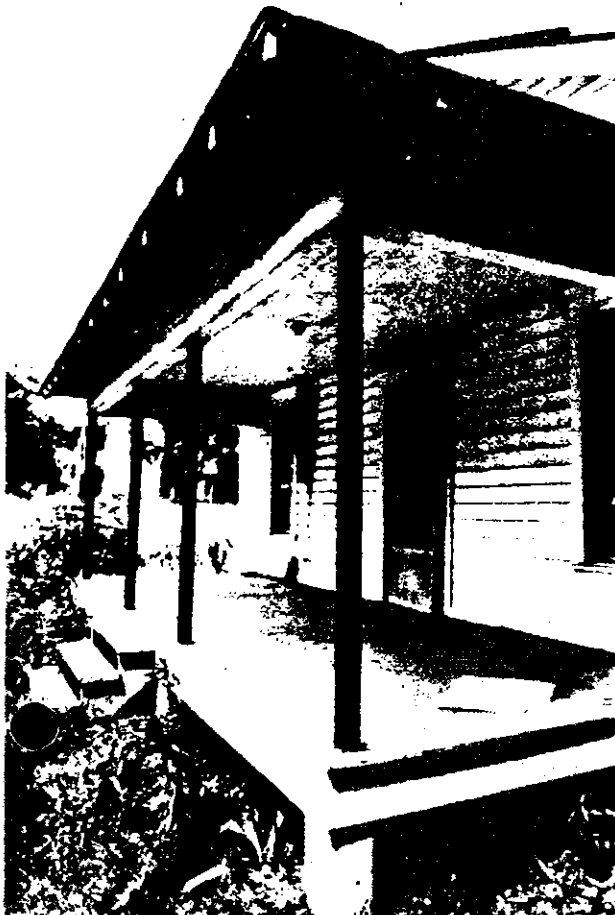
Porch: An 8'2" wide x 22'5" long porch extends across nearly the entire southeast facade of the dwelling; the deck, which is raised above the ground approximately 2', is supported on wood joists by four evenly-spaced 7" x 8" concrete piers and consists of 3 1/2"-4 1/4" tongue and groove boards which are painted medium gray. A hipped roof supported by four unevenly spaced 3 1/2" diameter iron columns roofed with asphalt shingles covers the deck. The deck is reached by ascending four unpainted wooden steps 50 1/2" wide x 10" tread. Risers measure 6 1/2" except for the first step which has a 3 1/2" rise. There is also a 3/4" rise from the top step to the porch deck. Eaves and raking trim on the porch consist of open verges.

Close-up of porch attached to the southeast elevation of the Roanoke Methodist Protestant Church parsonage in 1981. Note piers and steps as well as details of roof construction.

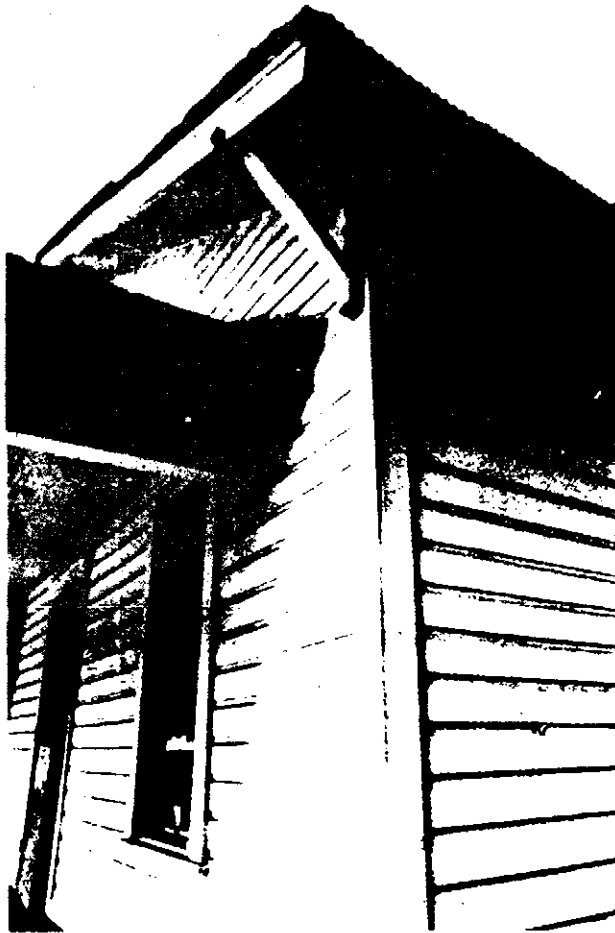
Walls: The walls are composed of 5 1/4" German cove siding with corner boards; the siding and corner boards are painted white.

Roof: The roof is a medium-pitch gable variety built with 2" x 6" rafters on 2' centers without a ridgeboard. It is covered with corrugated sheet metal; eaves trim consists of open verges with a frieze board below; raking trim consists of a fascia board and brackets at the corners.

Close-up of corner boards and German cove siding at the east corner of the Roanoke Methodist Protestant Church parsonage in 1981. Note the eaves and the gable bracket detail which is typical for this structure.

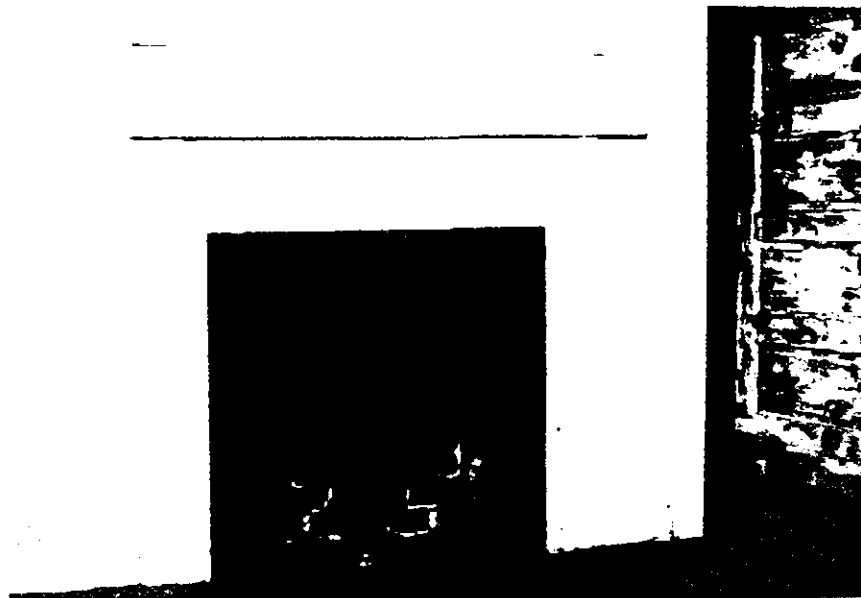
Fireplace: brick; coal burning grate; 1'3" x 3'9" concrete hearth; 1'10" wide x 2'4" high x 8" deep firebox; wooden mantle.

Close-up of the fireplace in Room 2 of the Roanoke Methodist Protestant Church parsonage in 1981. Note simple mantle, The doorway connecting Room 2 to Room 7 is visible at right.

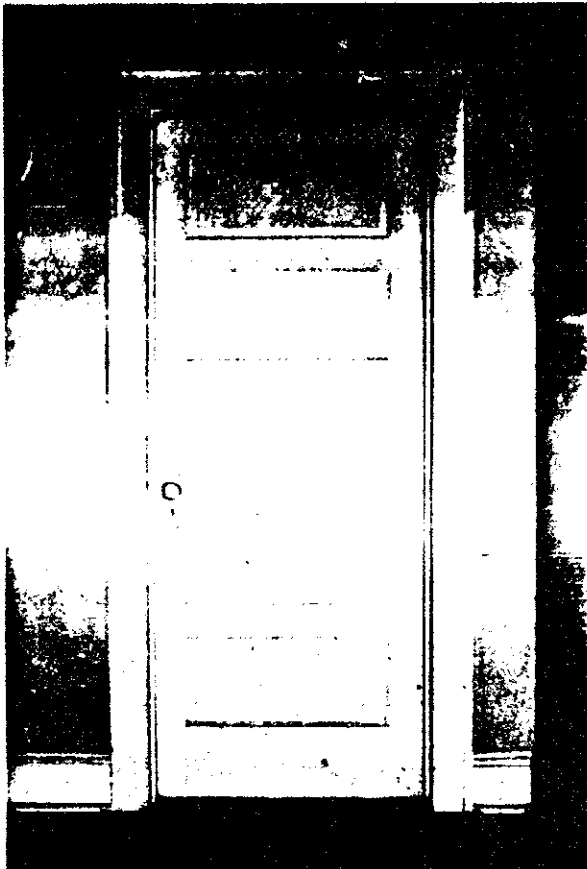
Close-up of a typical  
interior door in the Roanoke Methodist  
Protestant Church parsonage in 1981.

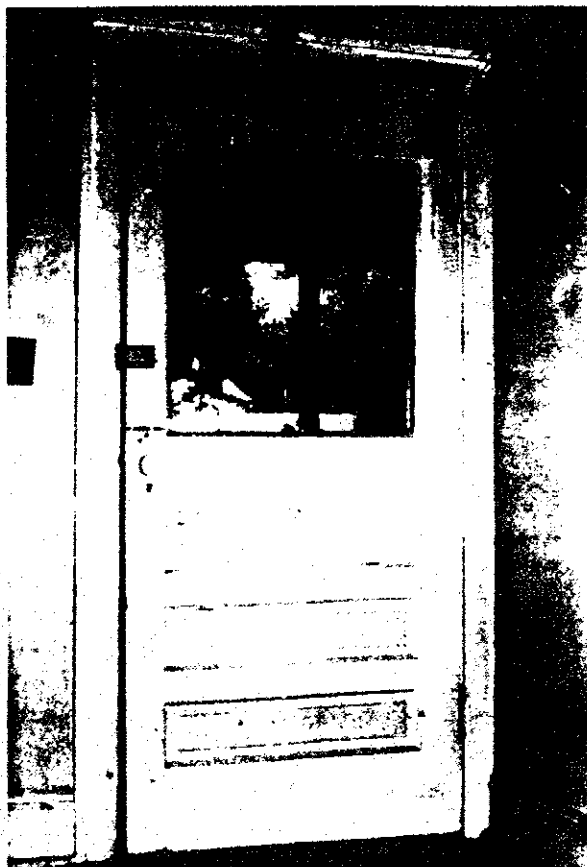
Close-up of the interior of  
the front door in the southeast eleva-  
tion of the Roanoke Methodist  
Protestant Church parsonage in 1981.

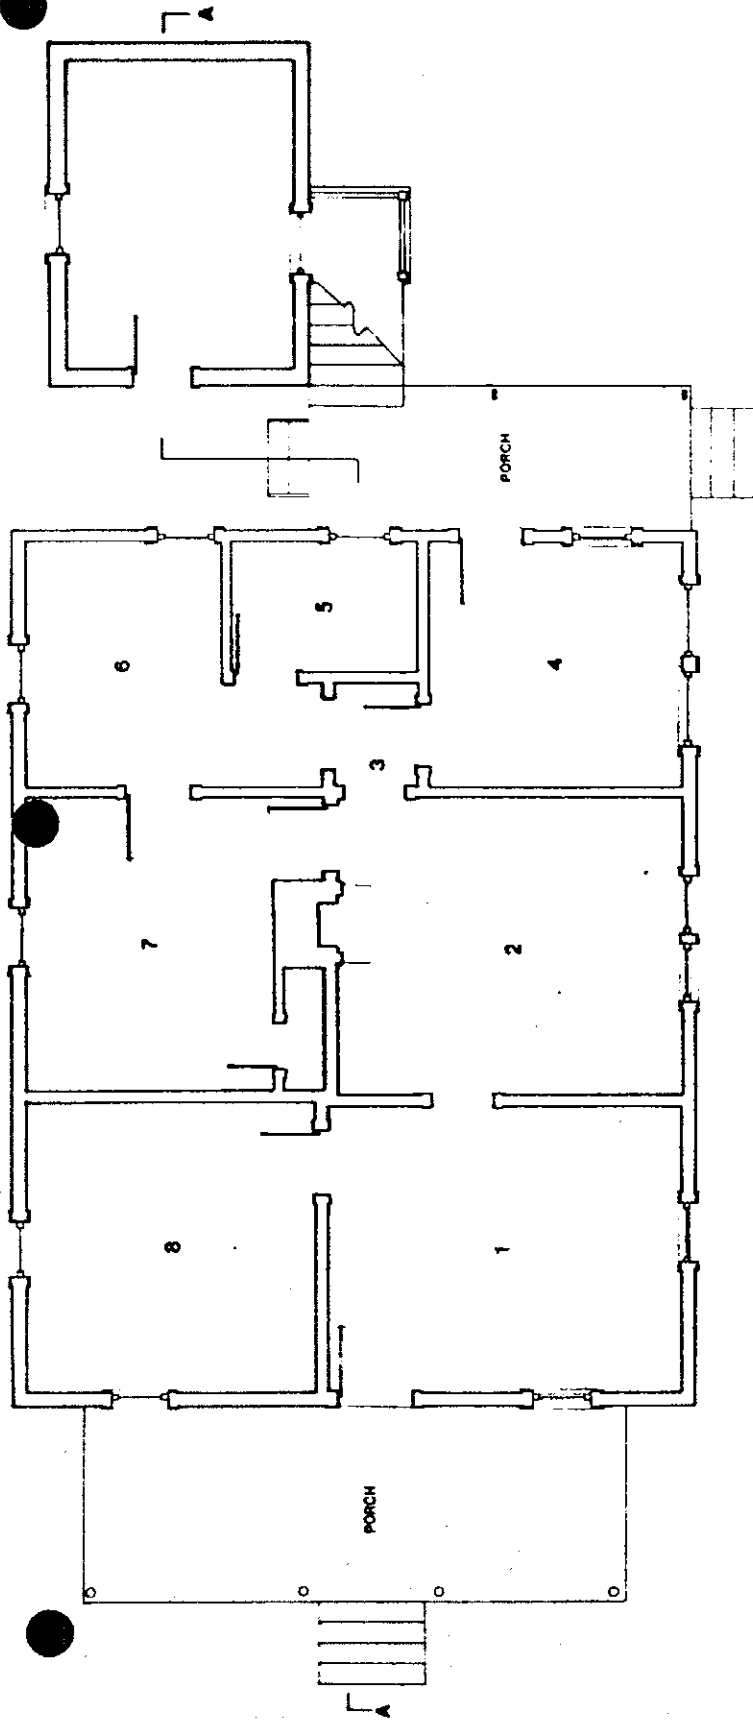
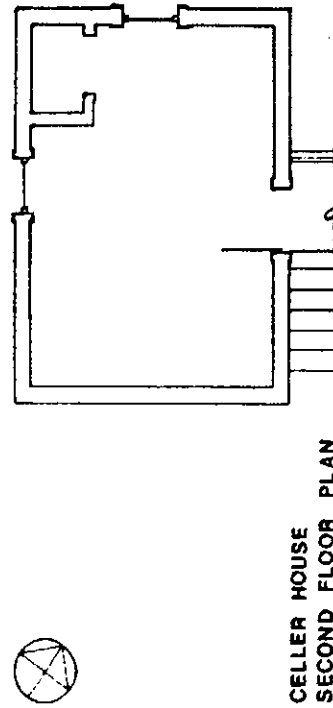
Floor plan of the Roanoke Methodist Protestant Church parsonage as well as first and second floor plans of the cellar house on the tract.

Interior Description: Room 1 (Room numbers are keyed to floor plan on page 20)

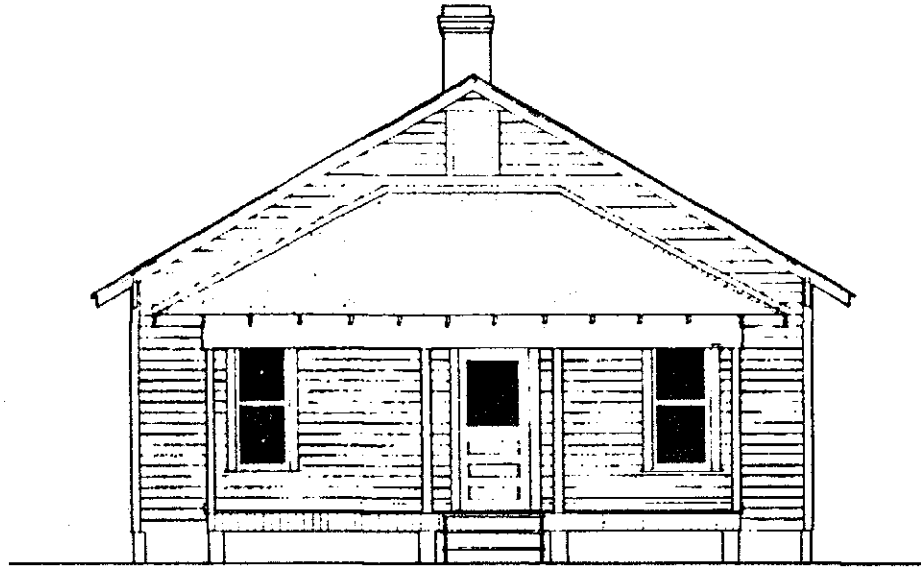
SOUTHEAST ELEVATION

Southeast elevation of the Roanoke Methodist Protestant Church parsonage.

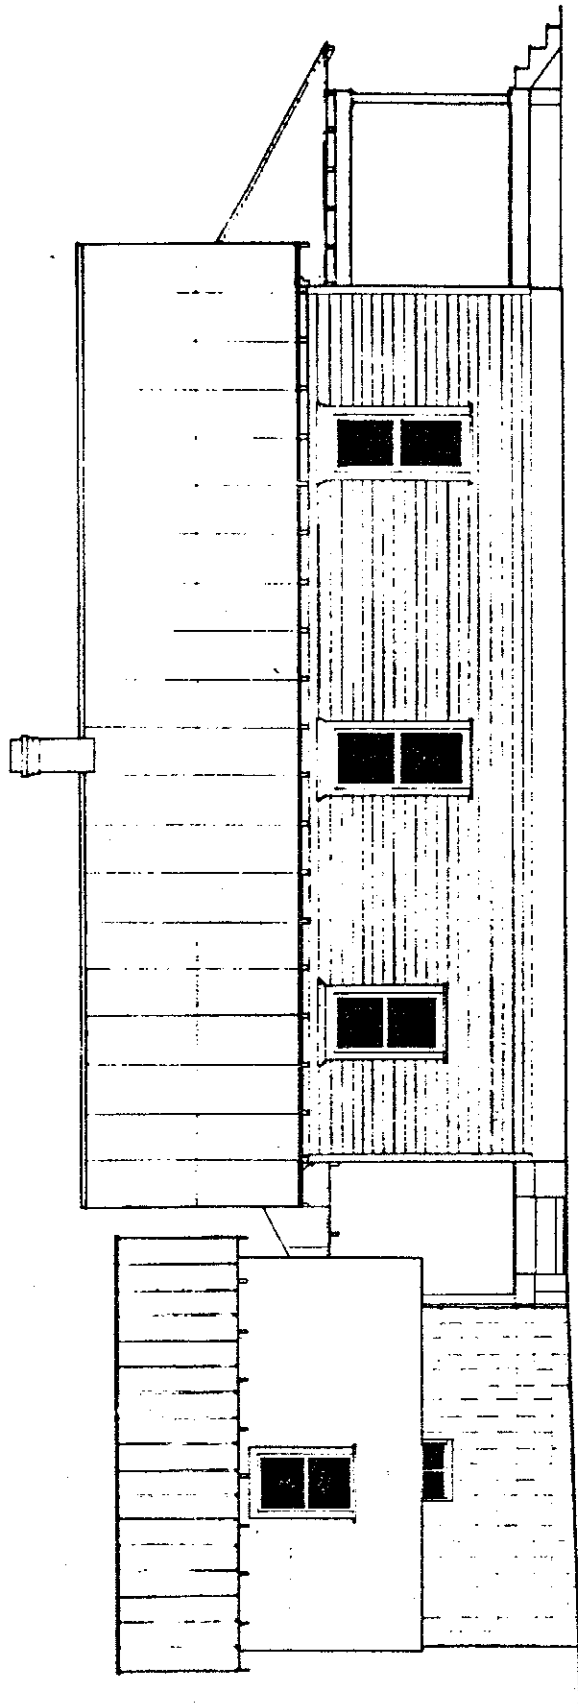
SOUTHWEST ELEVATION  
1 2 3 4 5 10'

Southwest elevation of the Roanoke Methodist Protestant Church parsonage.

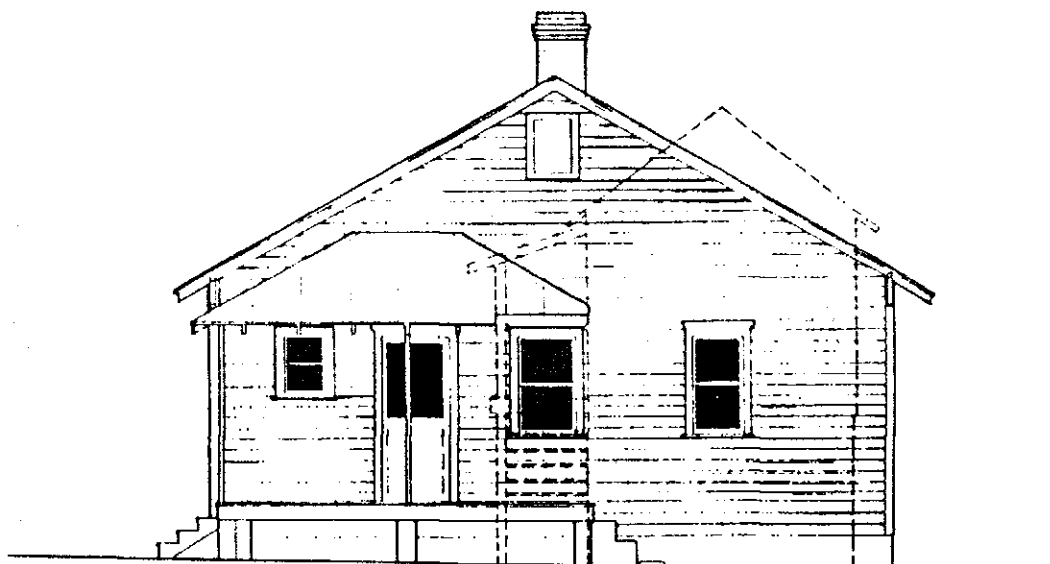
**NORTHWEST ELEVATION**

Northwest elevation of the Roanoke Methodist Protestant Church parsonage.

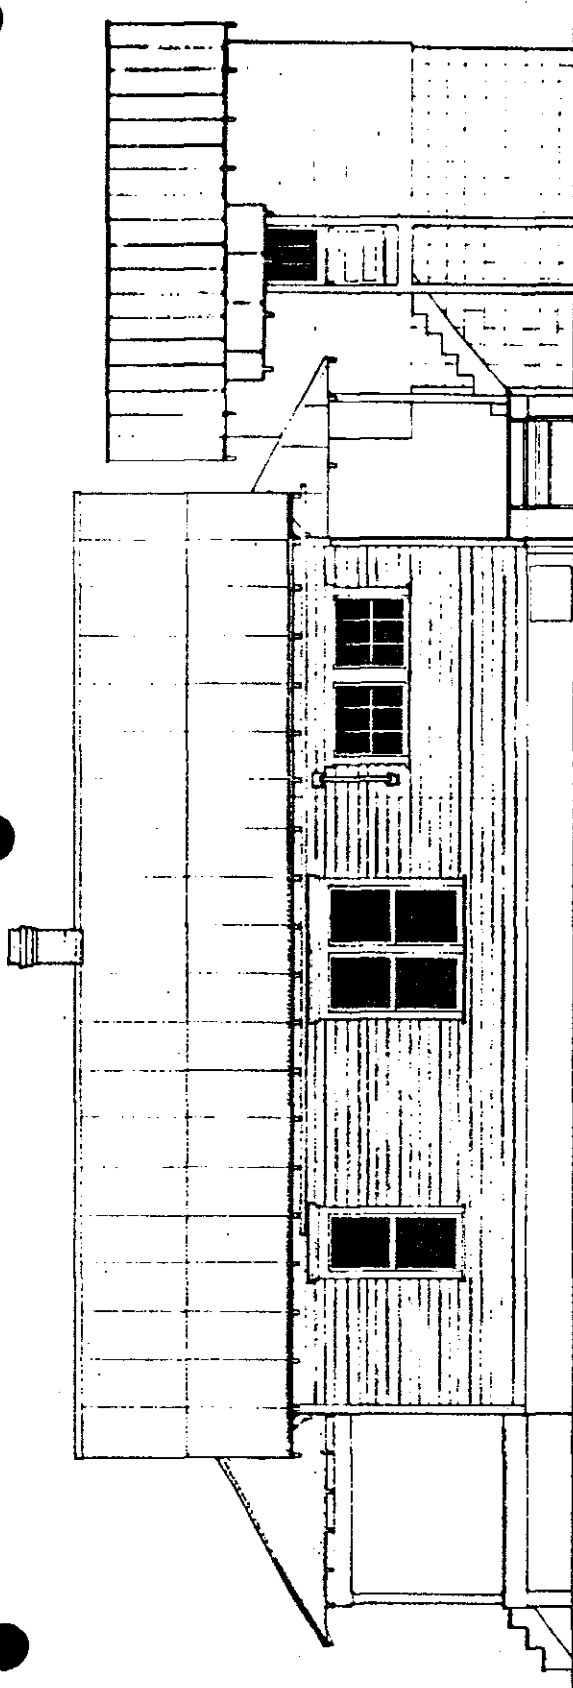
NORTHEAST ELEVATION  
1 2 3 4 5 10'

Northeast elevation of the Roanoke Methodist Protestant Church parsonage.

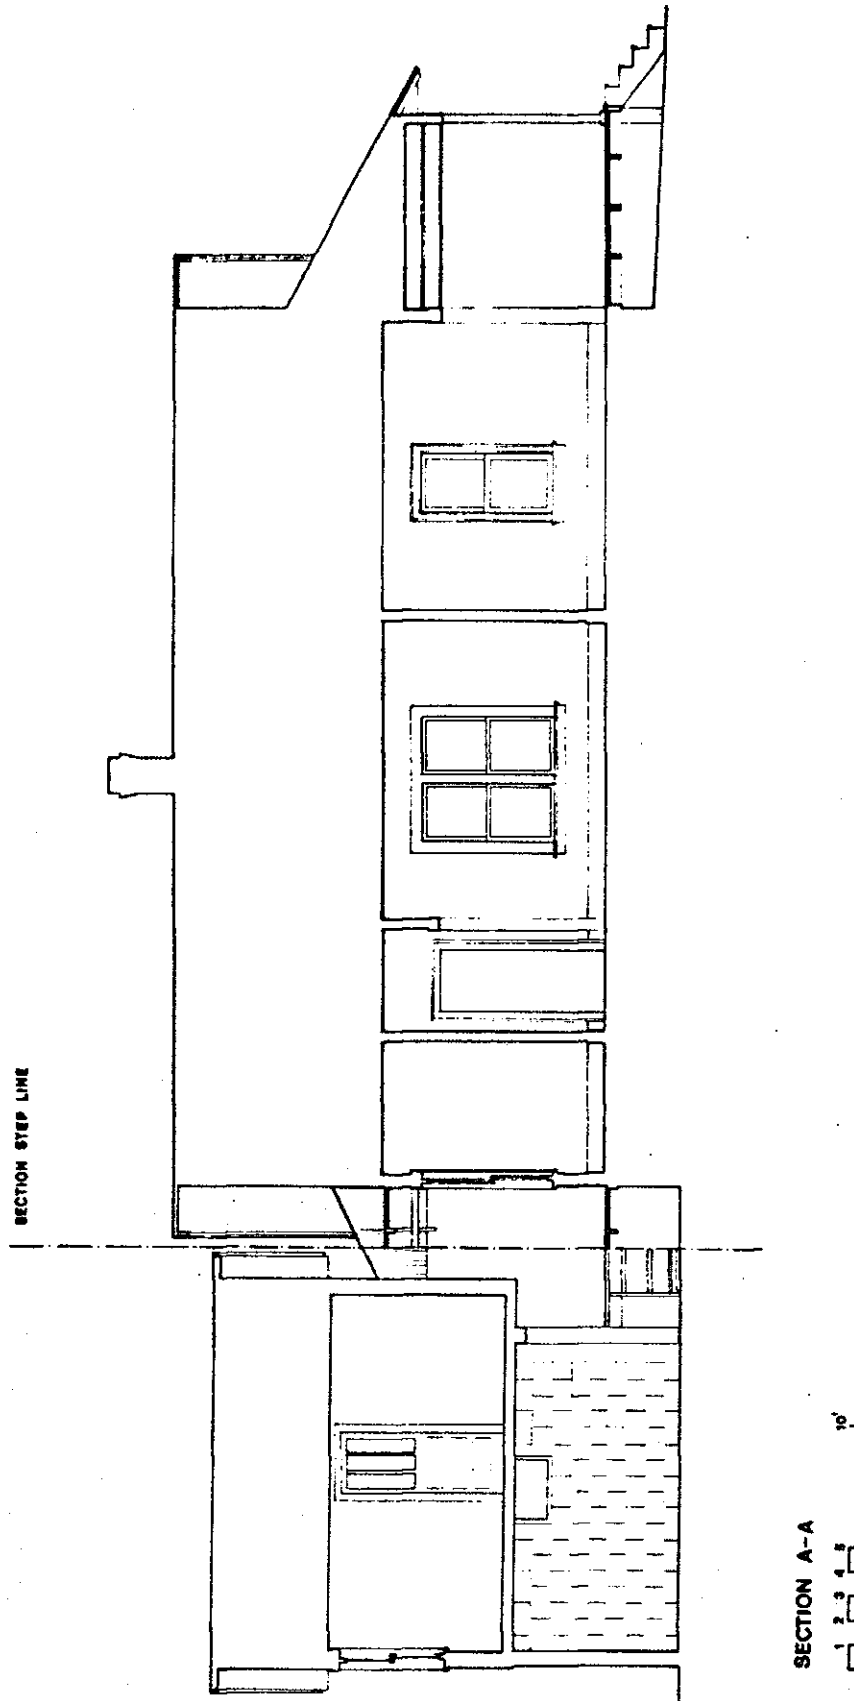
Longitudinal section (A-A) through the Roanoke Methodist Protestant Church parsonage.

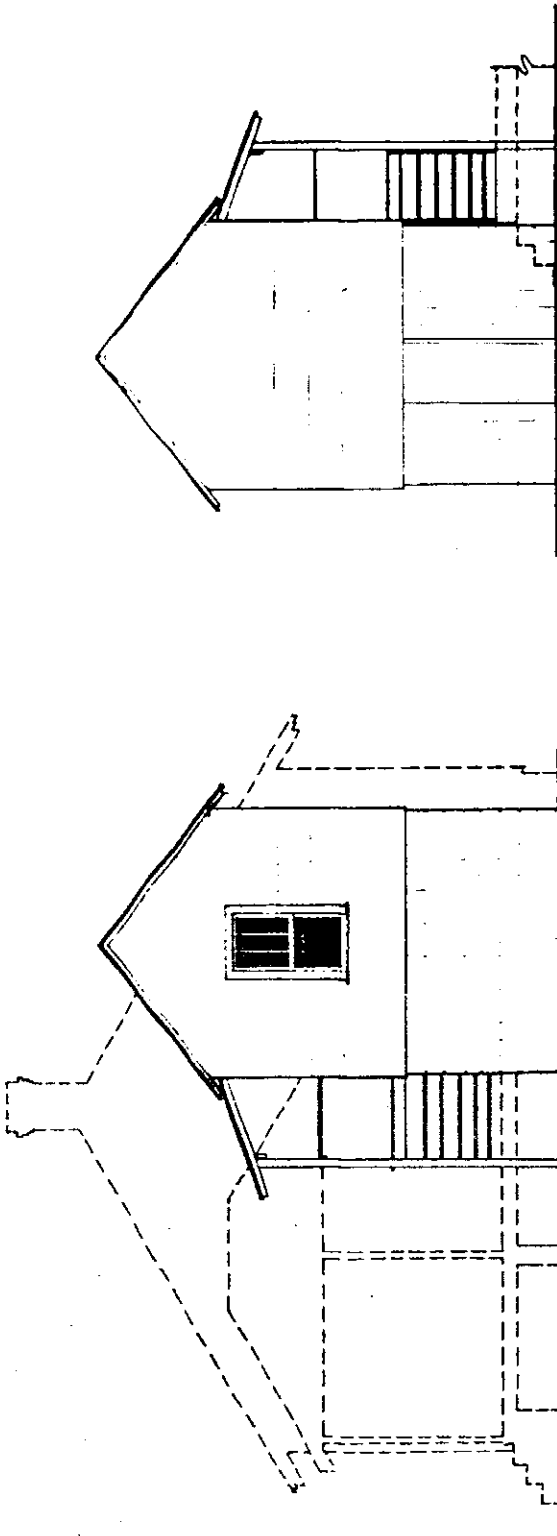
Northwest and southeast elevations of the Roanoke Methodist Protestant Church  
parsonage cellar house.
